THE LESOTHO HIGHLANDS DEVELOPMENT AUTHORITY (LHDA)

NOVEMBER 2006 FLOOD DOWNSTREAM OF THE KATSE DAM STRUCTURE

Effects of the November 2006 Flood

THE DAMAGE CAUSED BY THE FLOOD AS IT PROPAGATES DOWNSTREAM

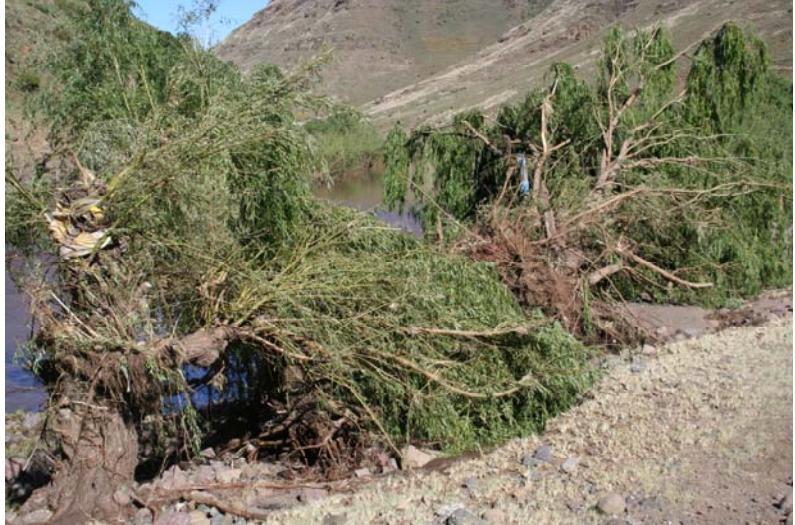
Figure1

Much damage was also observed where trees were uprooted and valleys eroded along side the main Senqu River channel and on both flood plains and the river – banks. The farm fields that are close and/or on flood plains were also deeply scoured and eroded.

Figure 1 below indicates the severity of the impacts caused by the November 2006 flood.

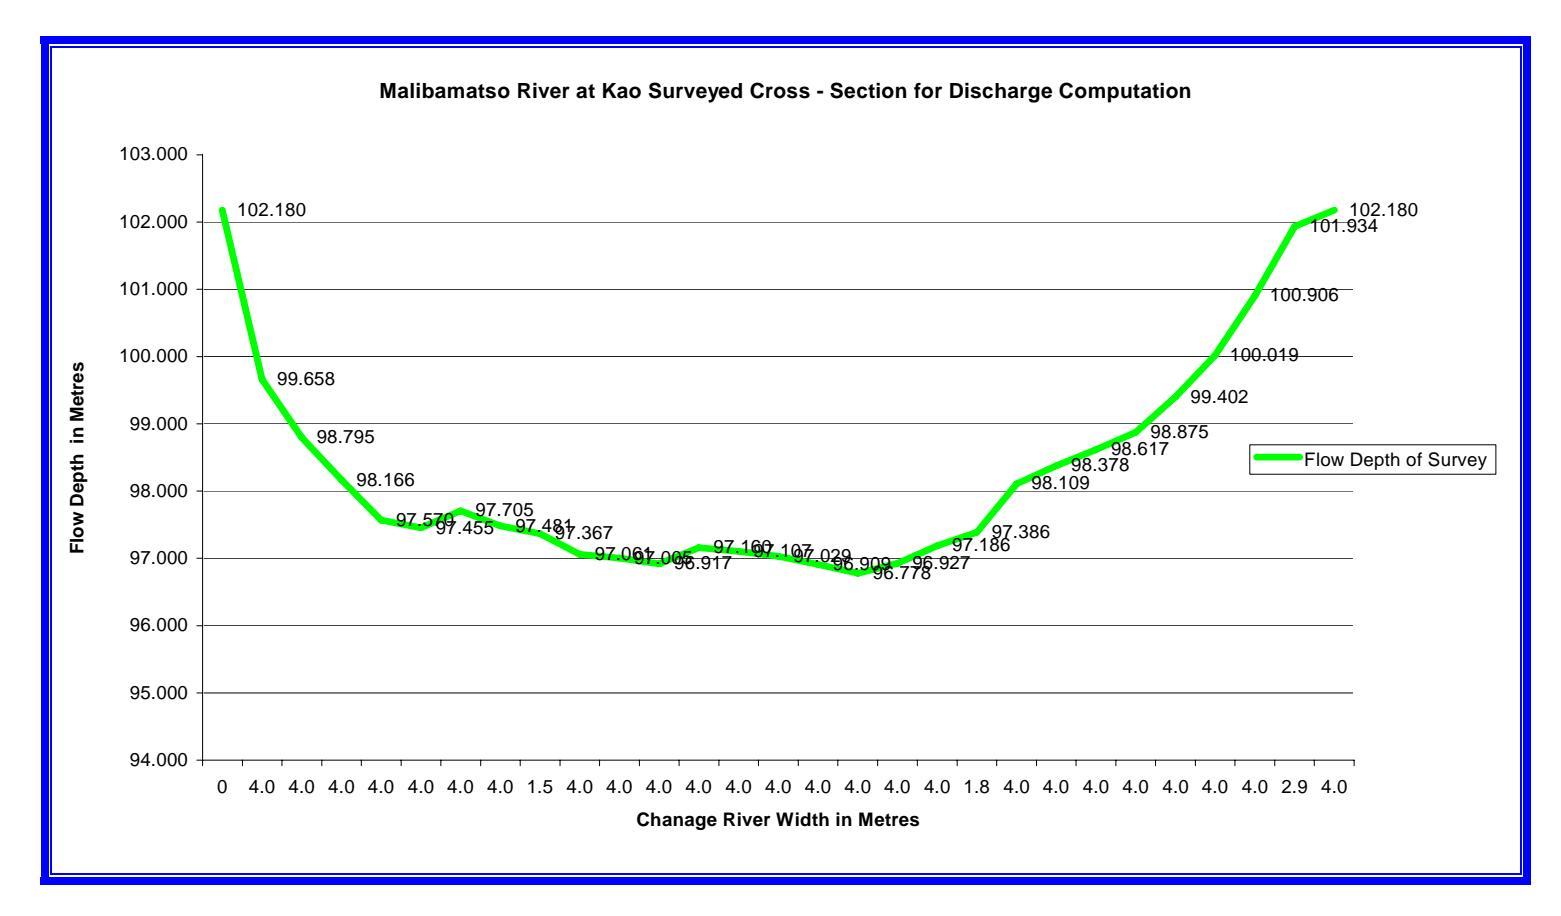
Chart 1

This cross – section shows that the river – banks are very steep and the flood plains are not visible. The river – banks are supported with a solid rock, very big rock boulders and some finer rock particles. Intensive vegetation of grasses, shrubs and medicinal plants have grown on this banks; adding some value to the manning roughness coefficient and some resistance to soil erosion by the exertion of frictional forces against the strength of flow. Thus no damage was seen or evident at and around this cross – section.

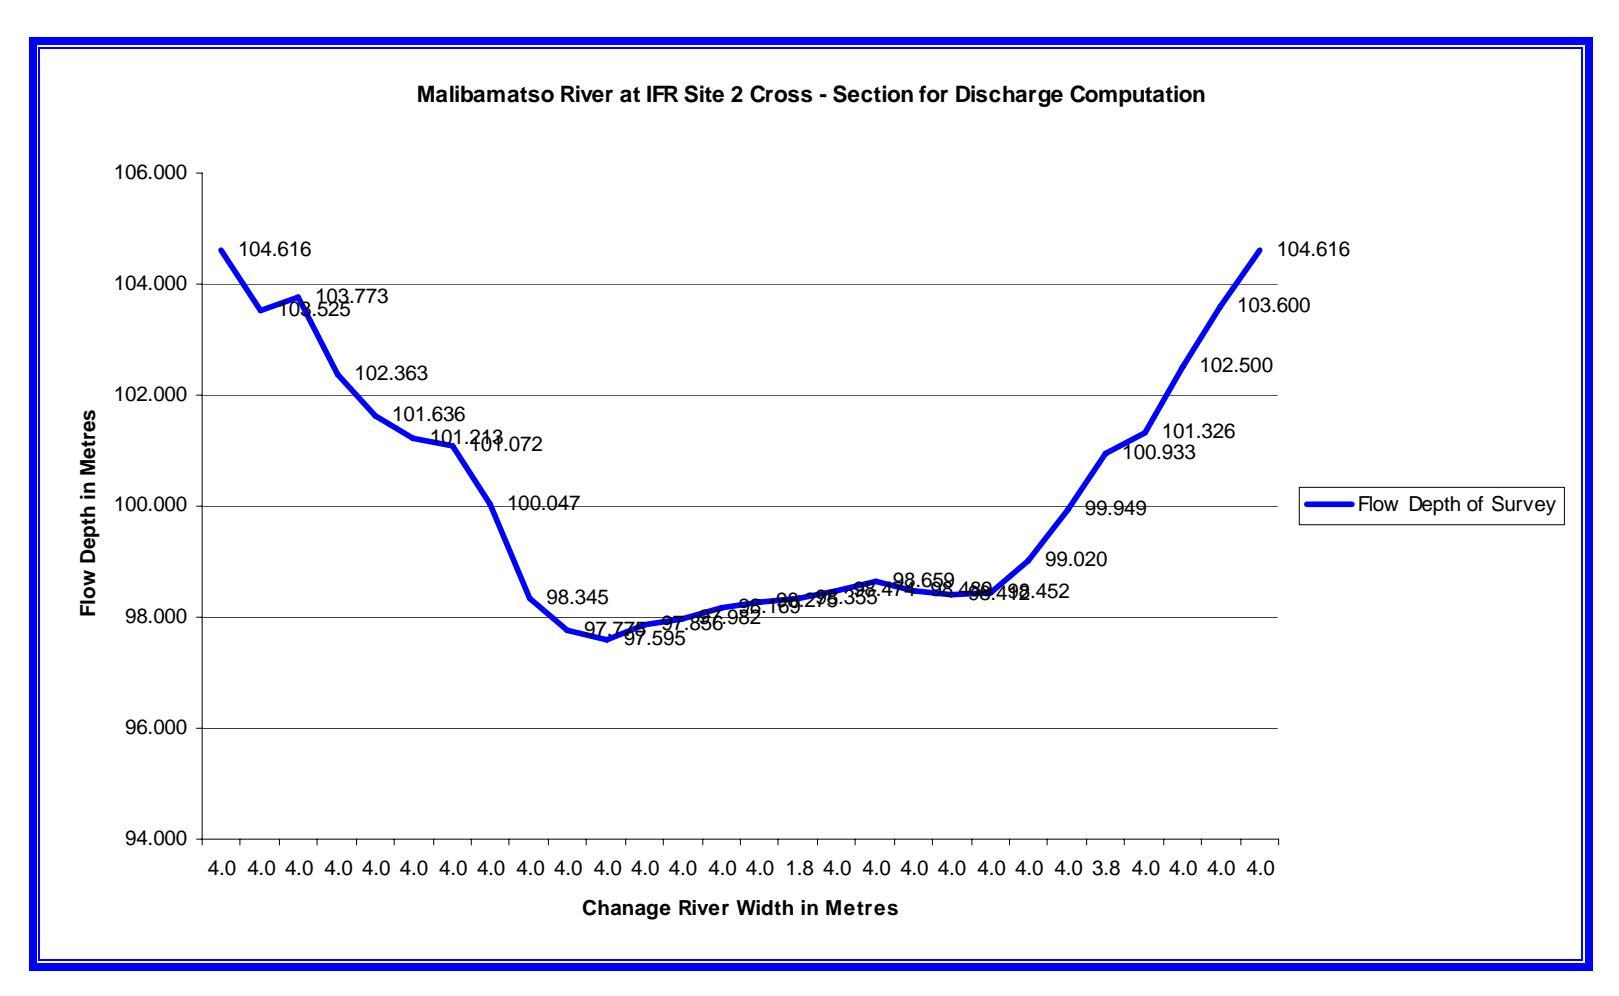
Chart 2

This cross – section shows that the river – banks have high gradients with smaller and sloppy flood plains. Intensive vegetation of grasses, shrubs, medicinal plants and some trees have grown along side the river – banks and on some of the Islands within the main channel.

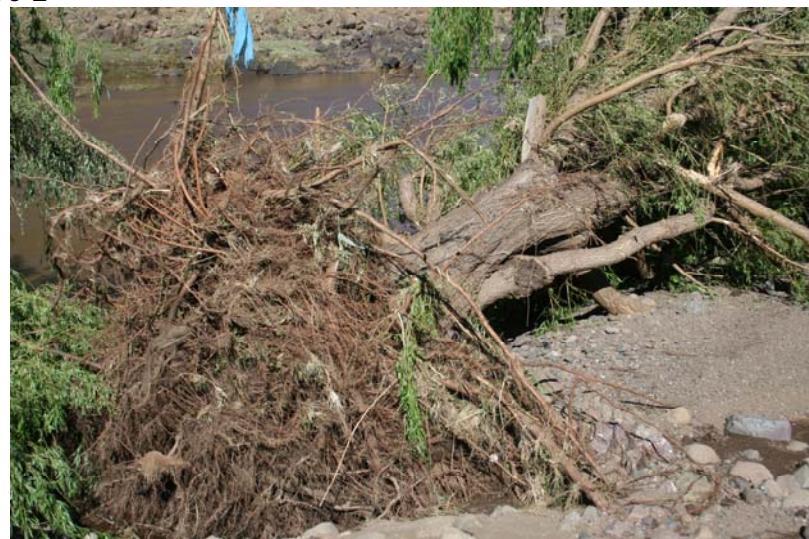
Figure 2

Much damage was seen to have occurred on uprooted trees and eroded fields on flood plains, see figure 2. The culvert on Khohlontšo stream was destroyed and washed away, some valleys forming channels were established along side the main river channel and the newly constructed Hydrometric station at IFR site 2 was destroyed and washed off, see figures 3 and 4.

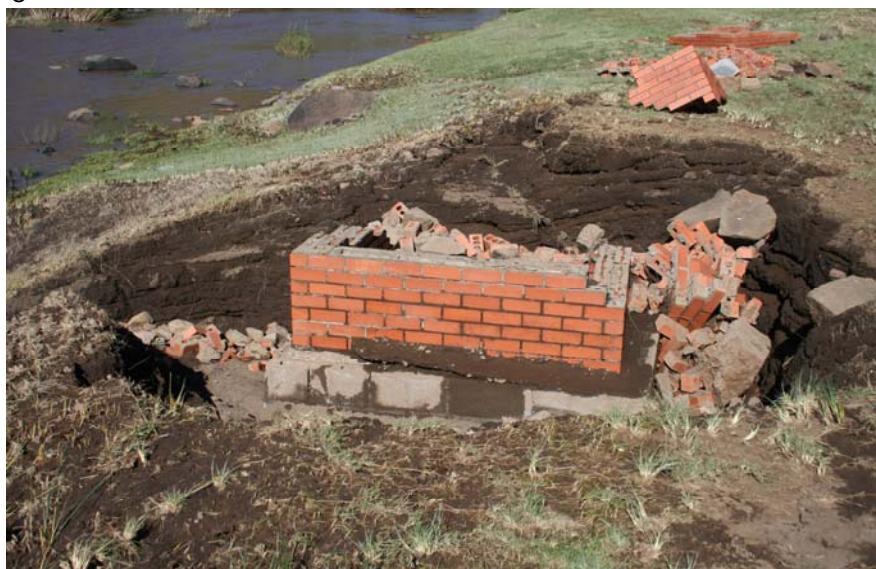
The peak magnitude of this flood has been calculated to be 1345.29 m^3/s and its corresponding specific force has been computed as 3.2 X 10^7 Newtons. This is a huge amount of force that uprooted trees and destroyed the newly constructed hydrometric station at IFR site 2.

Figure 3 below shows the impact caused by this huge amount of specific force.

- The reconstruction of the hydrometric station at IFR site 2 must be fast tracked and the structure be reinforced and designed to overcome floods of this magnitude. The specific force of flow to be designed for is 3.20X10⁷ Newtons.
- The surface area of the upstream side of the station must be reduced so that there is minimal resistance to flow. The triangular structure on the upstream side is recommended.
